Technical Memorandum

New Bedford Harbor Superfund Site

Subj: Operable Unit 3 Pilot Underwater Cap: Post-Cap Monitoring Update

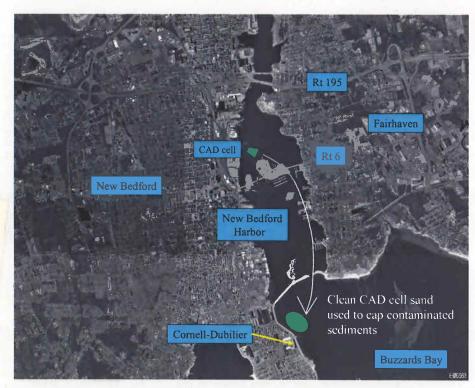
Figure 1: location of the ou3 pilot cap and port CAD cell

This provides an update on the post-cap monitoring data collected to date at the Operable Unit (ou) 3 pilot underwater cap located just south of the New Bedford Harbor hurricane barrier. This 19 acre cap was completed in July 2005, using clean sand and gravel from a port of New Bedford navigational Confined Aquatic Disposal (CAD) cell (Figure 1). The pilot cap covers PCB-contaminated sediments near the Cornell-Dubilier mill in shallow water along the New Bedford Harbor shoreline (Figures 1 and 2).

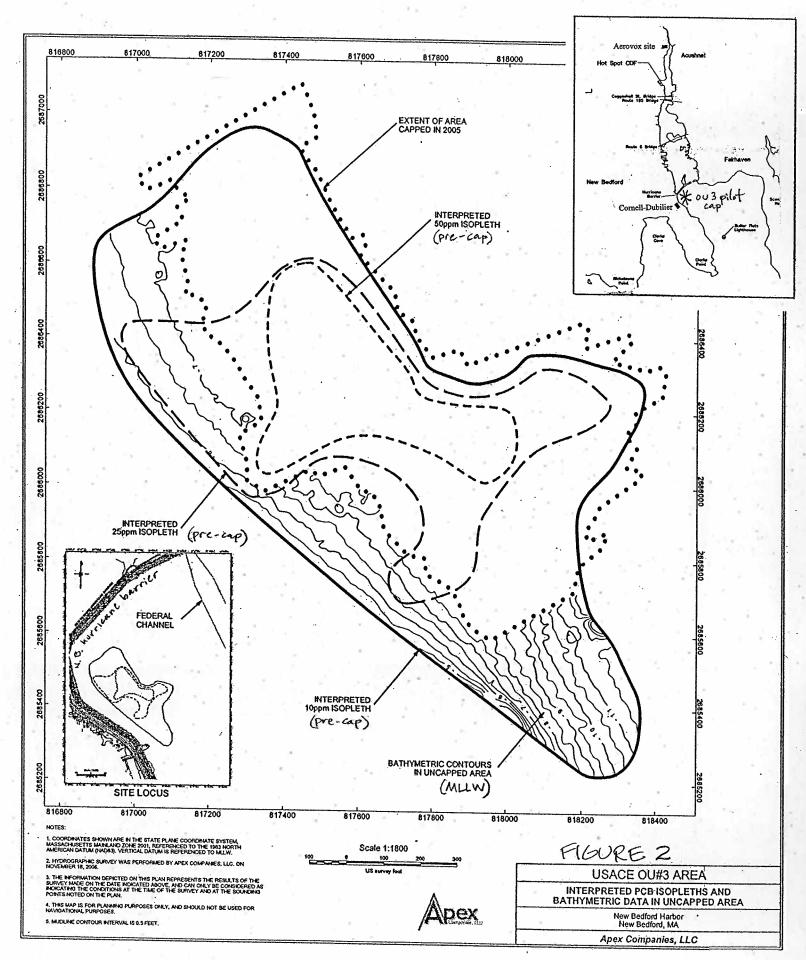
Due to the shallow water depths (Figure 2) and the size of the split-hull scows used to place the cap material (Figure 3) the cap surface resulted in a series of SW/NE trending ridges and valleys corresponding to the location of each scow at the time its cap material was released (Figure 4). Loaded dump scows could not be placed immediately next to previously placed cap mounds for fear of grounding in the shallow water environment.

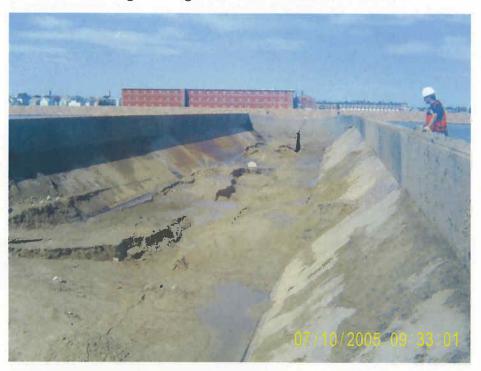
Figure 3: a split-hull scow begins opening to place cap material

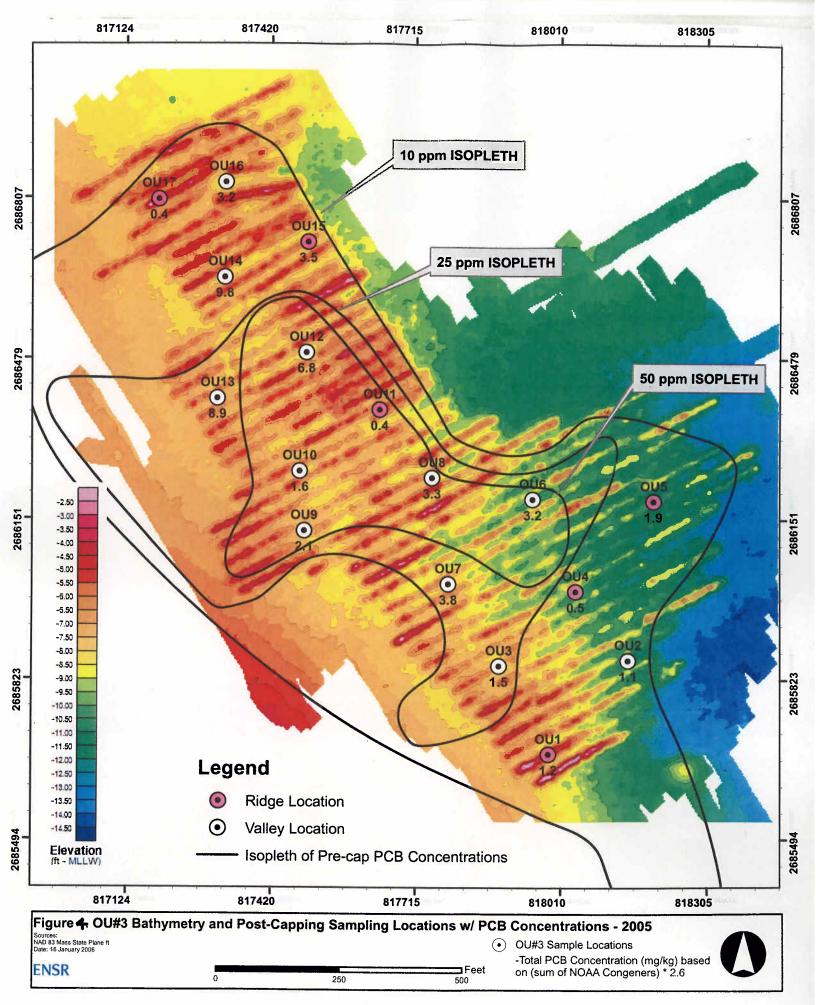
While overall the post-cap sediment PCB levels show good results, the PCB level at station #13 has almost doubled (from 8.9 to 17 ppm) between the 2005 and 2006 sampling events. As shown in Figure 4, station #13 is a valley location near the western edge of the placed cap material in close proximity to the 50 ppm pre-cap isopleth. These features may help explain the observed results. Other potential causes are analytical chemistry variability or recontamination of the cap from abutting uncapped areas (water depths were too shallow to the west of this location to allow complete coverage of the PCB-contaminated area with the available equipment). Station #13 will be closely monitored in future sampling rounds (e.g., with duplicate sampling), and future pilot capping activities will consider this area for additional cap material.
